## Trojca 46 - BB Kongo Class & CV Unryu Class

Trojca - BB Kongo Class & CV Unryu Class (książka)

# BB Kongô Class & CV Unryû Class

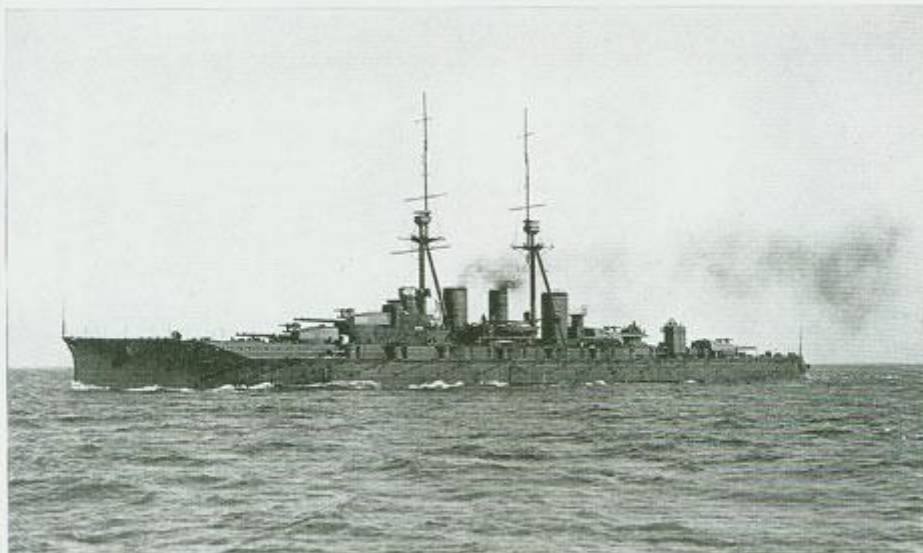
This photo may have been taken when BC *Kongō* navigated from the builder's yard to Belfast to enter the great dock there for cleaning and painting her bottom in preparation of the trials. The high rectangular-shaped container on both sides between #3 and #4 main gun turrets were used for metering the circulation of the boiler water and the supply of good quality pure water and mounted, of course, only for trials. This method was taken up by the IJN and applied until the trials of *Ise* and *Hyūga*. [Photo: Courtesy of Kure Maritime Museum].

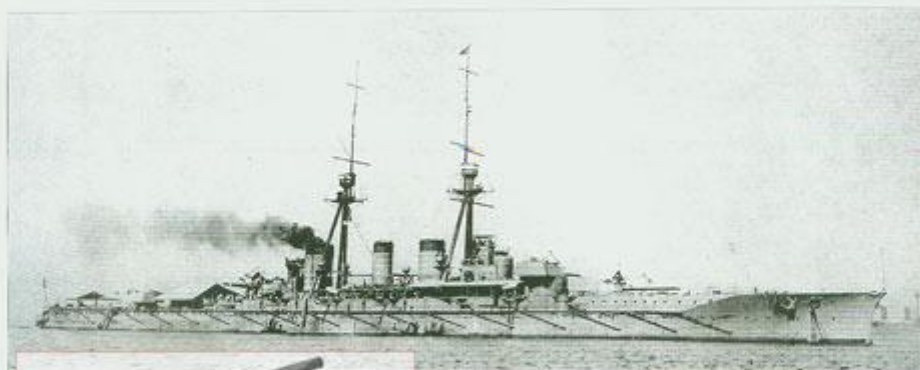
A very clear almost 100% view of BC *Kongō* as she appeared in 1914. She is anchored in Yokosuka naval port with #2 main gun turret turned to port and #3 turret turned to starboard. Her paint has changed from the dark grey to a very light one, but the main mast and support struts of the tripod masts are still dark. When Japan declared war upon Germany on 23 Aug 1914, she was the flagship of 1F 3S (First Fleet (Kantai), Third (Division) Sentai).

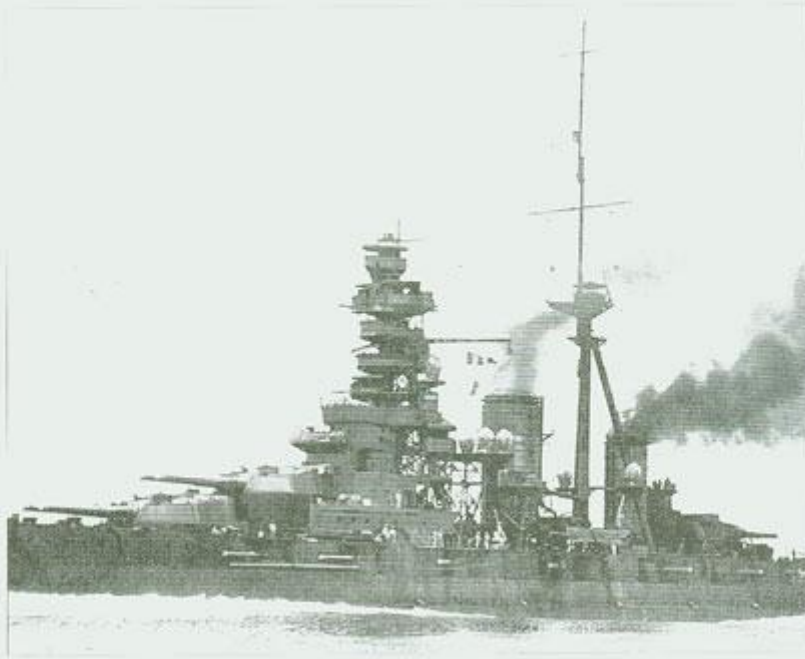
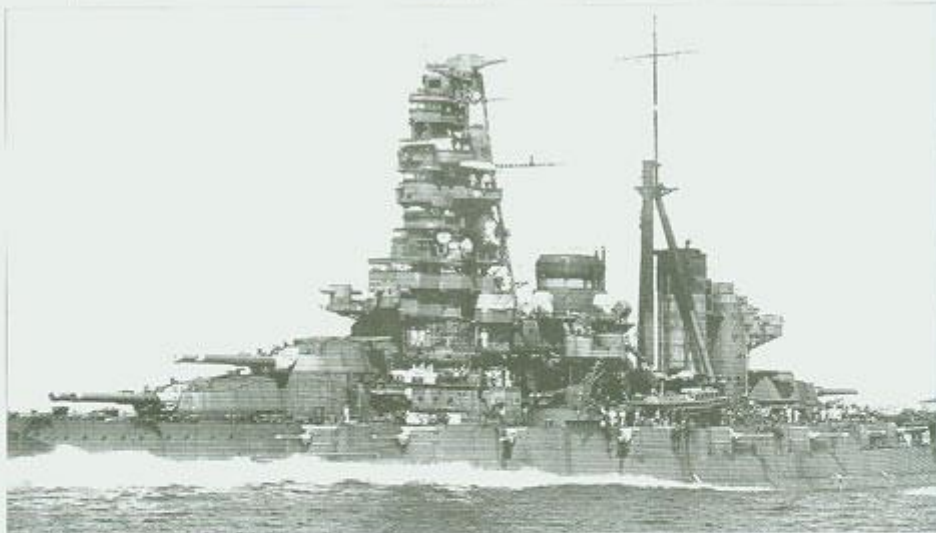
Midship of BC *Haruna* in 1928 (upper) after the first modernisation conversion and 1934 after the second one. Pay attention to the reversion of the height of the funnels beside of noting the complete revisions of foremast and after superstructure.
